# OIL CORROSION AND CONDUCTING CU<sub>2</sub>S DEPOSITION IN POWER TRANSFORMER WINDINGS

A2-111

# CLAES BENGTSSON<sup>1</sup>, MATS DAHLUND<sup>1</sup>, JAN HAJEK<sup>1</sup>, LARS F PETTERSSON<sup>1</sup>, KARIN GUSTAFSSON<sup>2</sup>, ROBERT LEANDERSSON<sup>2</sup>, ARNE HJORTSBERG<sup>3</sup> <sup>1</sup>ABB Power Technologies AB, Ludvika Sweden <sup>2</sup> ABB Corporate Research, Västerås Sweden <sup>3</sup> ABB Corporate Research, Baden Switzerland

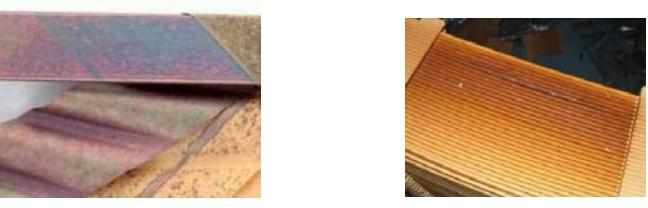
Fig 1. Corroded copper conductor (left) showing clear  $Cu_2S$  deposition on the wrapping paper. Right shows deposits on paper between spacers in disc winding. This type often also contains sludge.

Deposits have also been observed on the outside of the paper wrapping as shown in fig 1. In this case deposits are observed which sometimes appear more fundamentally different in type, with varying colours and general appearance but also with different chemical and electrical properties. A large variation in the electrical conductivity was observed, some with little or no conductivity at all, and others showing the typical conductivity of  $Cu_2S$  deposits. There is often a substantial amount of normal sludge in these deposits.

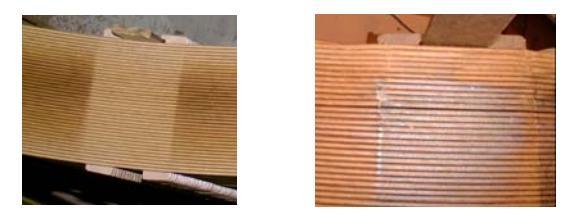
Fig.3. Examples of deposition between spacers left, and under spacer right

In disc windings we have observed that the amount of deposition can sometimes vary drastically close to versus under a spacer, from low too high or from high to low, as shown in fig 3 below. In both cases the temperature is similar but somewhat higher under the spacer, since the oil has no access for cooling in this area. Clearly, other factors than temperature must play an important role for deposition here.

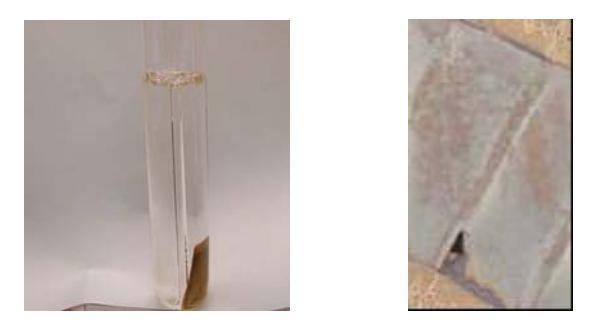
Fig 4. Laboratory experimental arrangement for Covered Conductor Deposition (CCD) test, and examples of  $Cu_2S$  deposition on Kraft paper

To investigate the cause of the deposition phenomenon, detailed laboratory studies have been performed. After a substantial variation of experimental parameters, the deposition of  $Cu_2S$  on the insulation has been reproduced in the laboratory. A flexible set-up was chosen, using IEC 61125 equipment, with a 3 cm long real copper conductor in a glass tube with 40 g oil. The conductor was wrapped in a few layers of insulation Kraft paper. A gas mixture can be bubbled through an inner glass tube to control the gas in oil content, in order to simulate the actual environment in a transformer as accurately as possible, and the temperature of the arrangement is conveniently controlled by an external thermostat. The complete set up for this Covered Conductor Deposition (CCD) test is shown in fig 4 below.

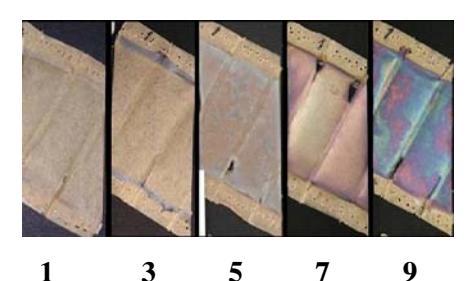
Fig.5. Scale for evaluation of CCD. 0 = no deposit, 5 thin covering of complete area, 10 very heavy deposition. This reading is used as a semi-quantitative measure of the amount of deposition.

The major overall conclusion from these deposition experiments is that only certain oils do actually create  $Cu_2S$  deposition. These oils are also the very oils that have caused real transformer failures in the field as will be discussed in section 4 below. For oils which do create corrosion and deposition the influence of various environmental parameters has been studied. A very large number (> 1000) of samples have been studied. In order to facilitate a simple quantitative evaluation of the amount of deposition a deposition scale 0-10 has been defined, as shown in fig 5 below.

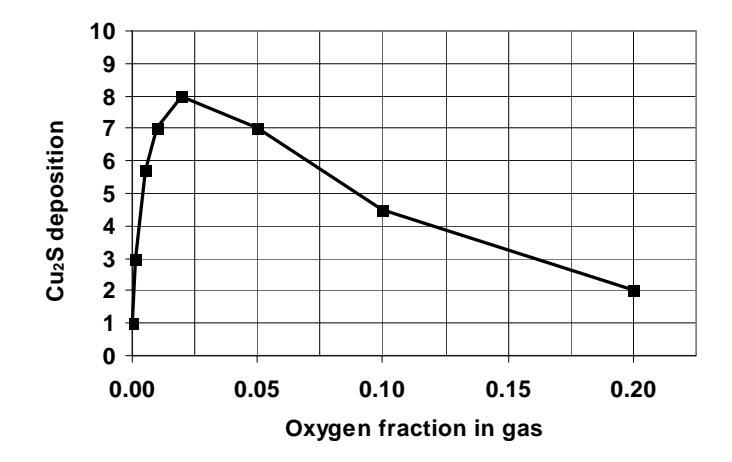
Fig 6. Relative deposition amount on Kraft paper in CCD test versus levels of oxygen in oil A. CCD- tests performed at 120°C for 32 days, 1 l/h of gas bubbled through oil.

When depositing oil is studied, very pronounced oxygen dependence can be observed as shown in fig.6 below for oil A. The amount of deposition on the paper increases dramatically as the amount of oxygen in the gas is increased from pure nitrogen. For the oil used in this case the amount of deposition has a maximum at approximately 2-3 % oxygen in the gas, corresponding to 3-5000 ppm in the oil, and then falls to a lower value at very high oxygen levels.

The interval in which strong CCD-deposition occurs is clearly in the range of normal transformer operation for sealed units, while the high end corresponds to the typical oxygen levels of free breathing transformers. In a general way these data may also indicate that sealed units would be more at risk than free breathing units, at least for the oil under study here.

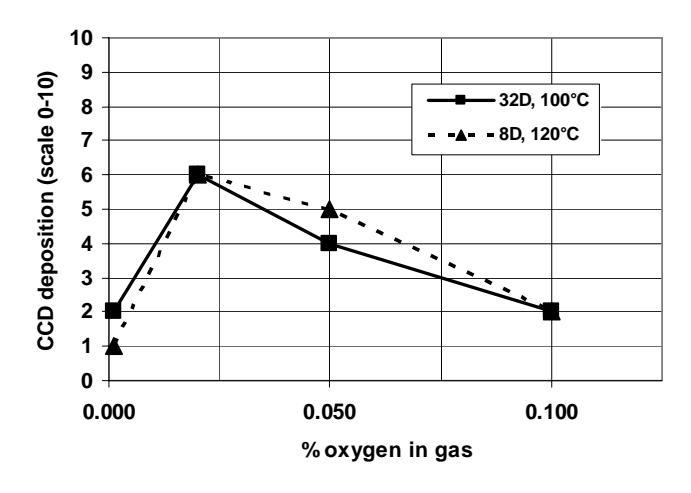
Fig 7. Relative deposition amount on Kraft paper in CCD test versus levels of oxygen in oil A. CCD-tests performed at 100°C for 32 days, and 120°C for 8 days, 1 l/h of gas bubbled through oil.

When sufficient oxygen is supplied to the CCD test the  $Cu_2S$  deposition is found to be thermally accelerated as expected. The rate of deposition is doubled after a 10°C increase, four times as high for 20°C etc. Figure 7 shows the amount of deposition after 8 days at 120°C and 32 days at 100°C with varying oxygen content in the gas for oil A. Evidently the deposits at each of these oxygen levels is approximately the same for the two series, i.e. 20°C temperature increase corresponds to a rate increase of approximately four times.

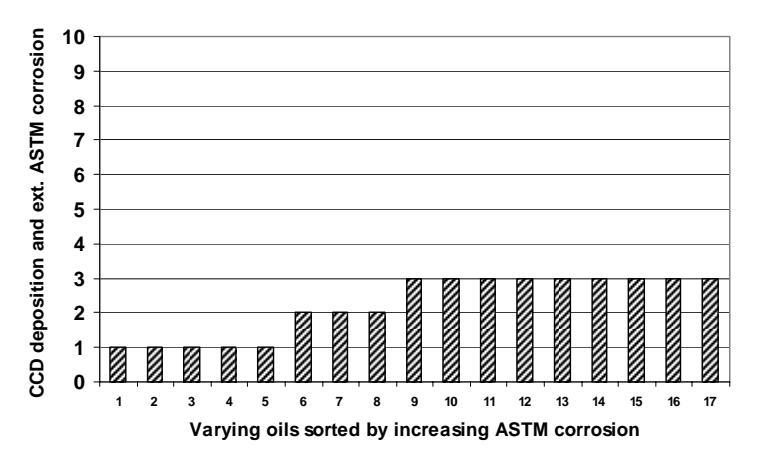
Fig. 8 Results of Extended ASTM D1275 corrosion tests for group of commercial oils

The results shows that all the oils tested here with the extended ASTM D1275 test actually did pass this tougher metal strip test, and hence also the standard ASTM D1275 test. We would accept all these oils, but would suspect oils 9-17 of be closer to being "corrosive". However, since there is relatively little variation between the oils it is hard to define a natural more stringent fail/pass criterion.

**Extended ASTM:** With the commonly used D130 criterion (<4) the extended ASTM method was not able to separate out any of the oils in the failure group. With a tougher criterion (<3) the complete group 9-17 would have to be disqualified. In this group then failure- oils 13, 16 and 17 would have been removed, but also oils in the No- failure group 2. Further oil number 7 in the failure group would still have passed. Clearly, the extended ASTM method cannot selectively identify depositing oils.

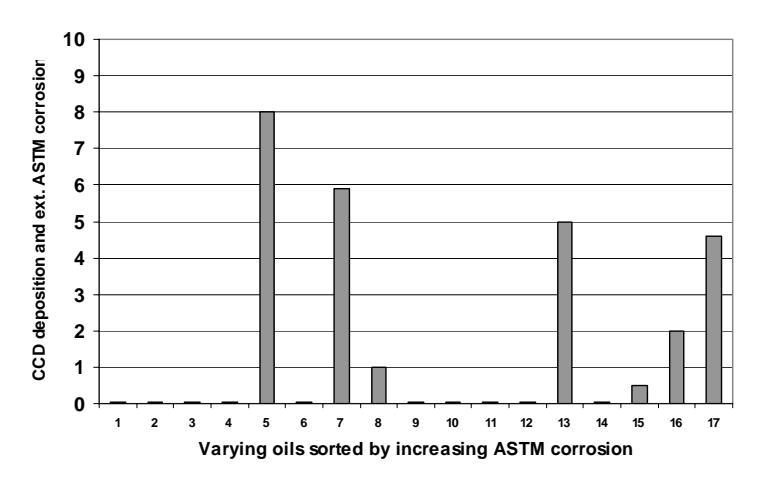
Fig. 9 Results from CCD test of selected group of commercial transformer oils

The same set of commercial oil samples have been tested and evaluated with CCD, showing a very good reproducibility. The results in Fig. 9 below show that there are large differences in  $Cu_2S$ -deposition between the different oils. Some oils show essentially no deposition. These oils also in most cases show no deposition even if the test is continued for longer time. Other oils have varying degree of deposition, in some cases extremely strong. If the pass/fail criterion is set to "less than 1", oils number 5,7,13,16 and 17 have clearly failed this test clearly, while number 8 is on the borderline.

**CCD:** With pass criterion deposition "1 or less", the CCD test would screen out oils number 7, 13, 16 and 17 as clearly depositing, and 8 as borderline. Hence all the confirmed depositing oils in the failure group1 (oils 7, 13, 16, and 17) were correctly identified by the CCD method, whereas the No- failure oil number 8 was on the borderline. If the pass criterion instead is set as "2 or less" the method correctly screens out exactly the known failure oils.
